ONE WORLD TRADE CENTER FIRE

New York, N.Y.
February 13, 1975

HIGH-RISE FIRE SAFETY

REPORT BY

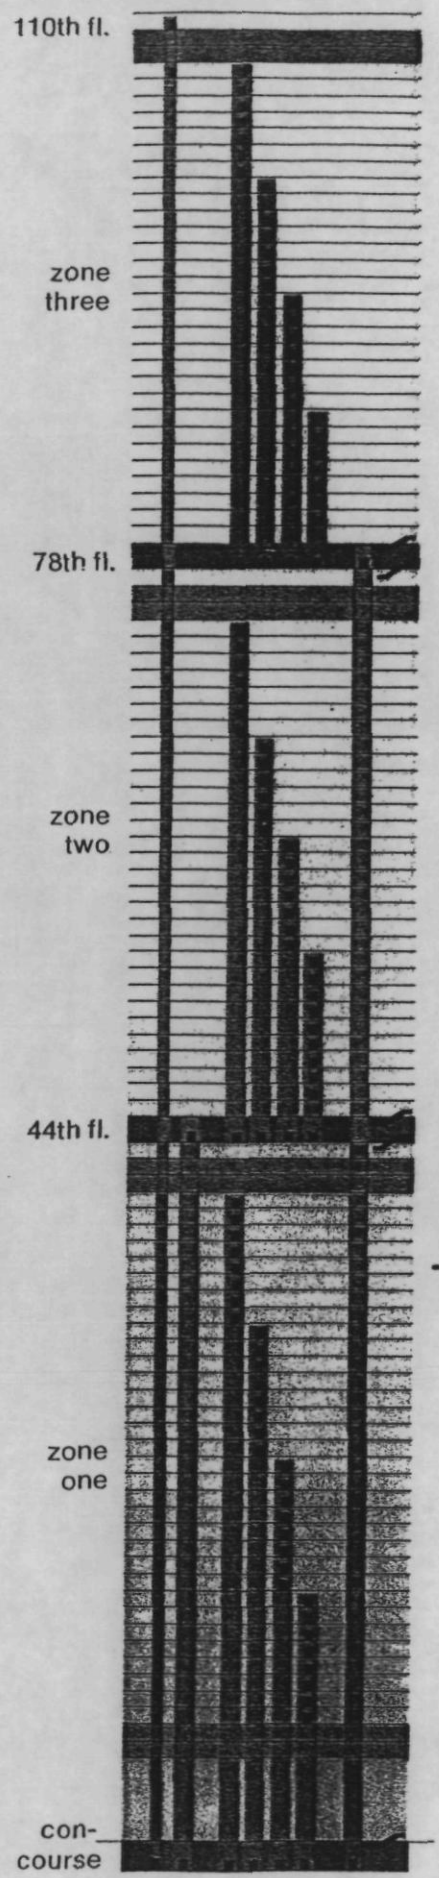
Schematic view of Tower building elevators shows how express and local runs are separated.

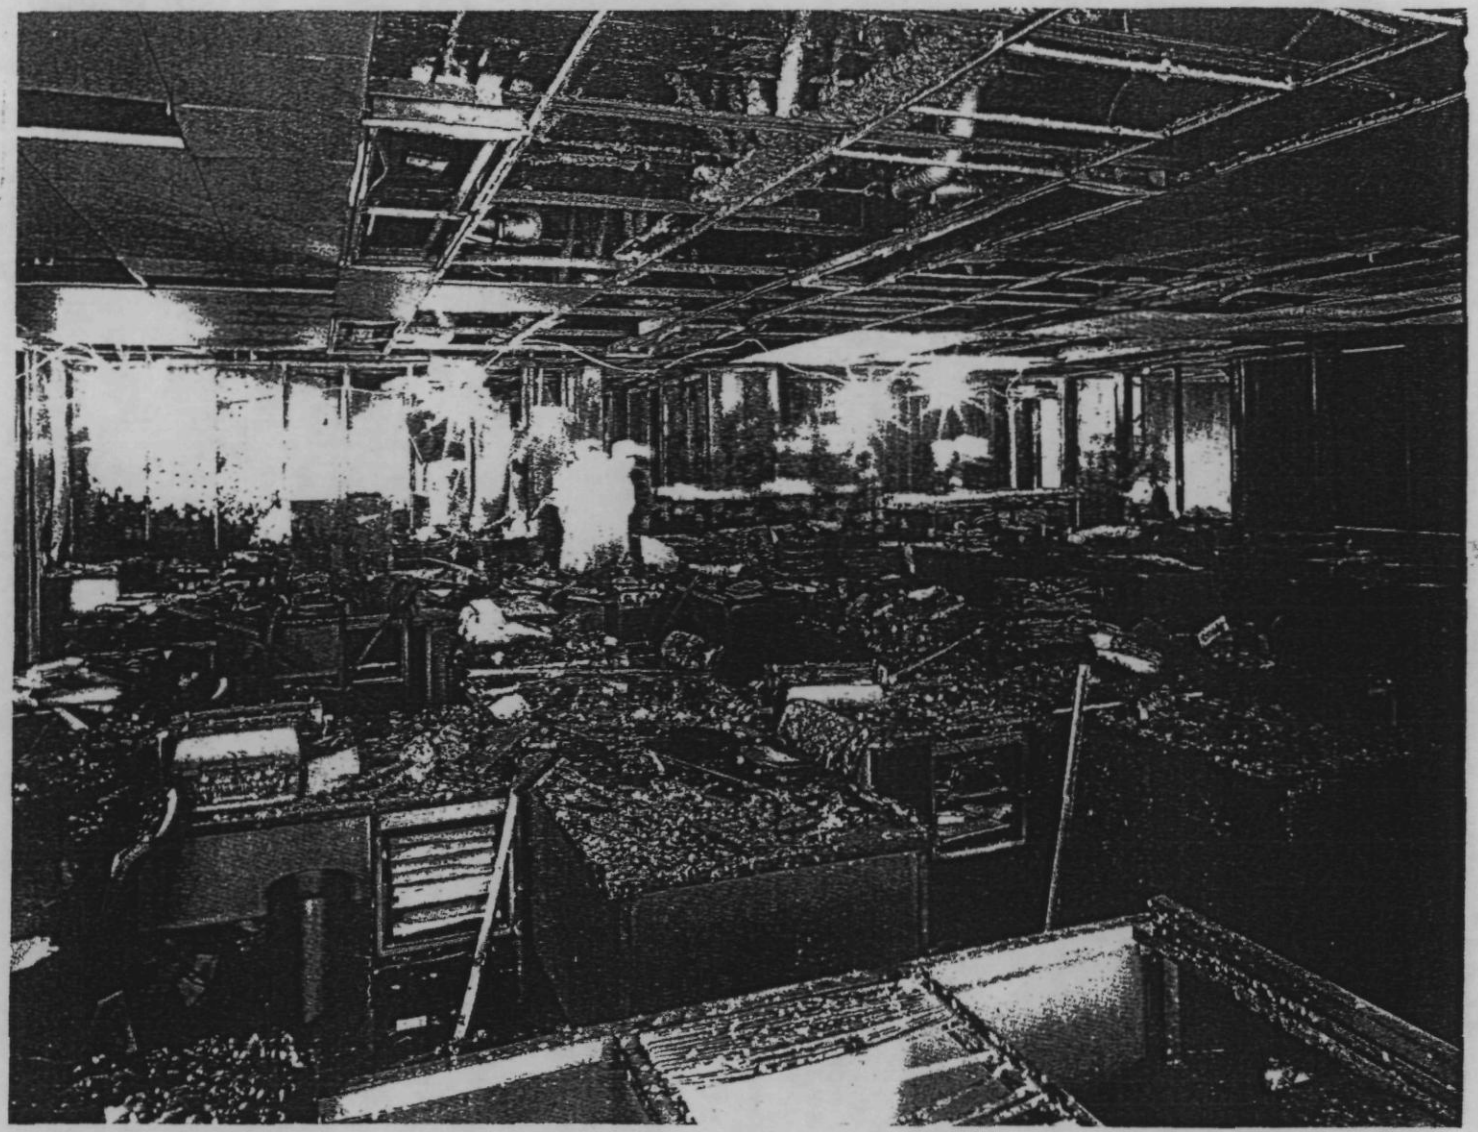
R. J. Saunders office on 11th floor file room is at left and office of fire origin is behind partition at right of picture.

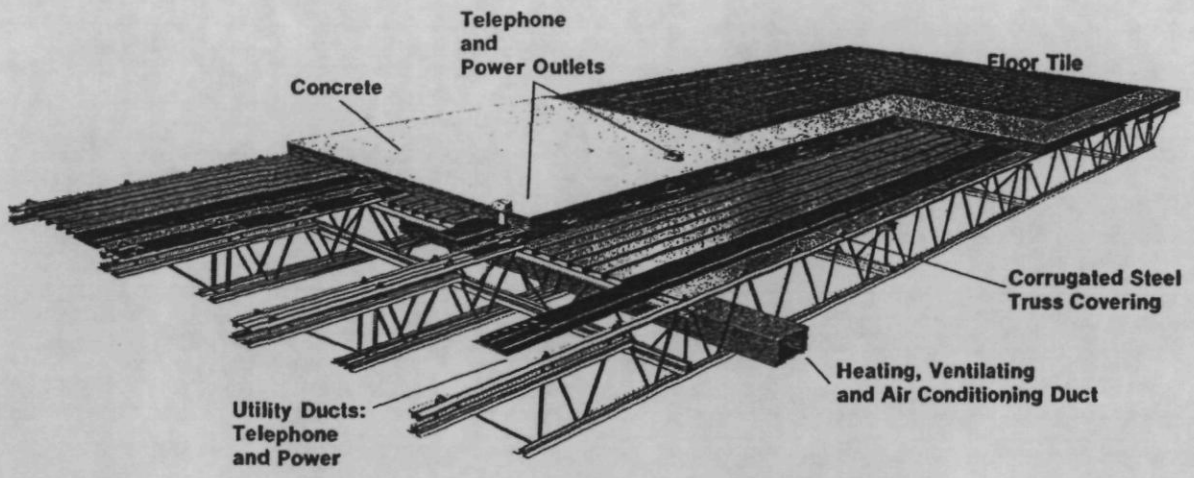
Floor truss in close-up detail. Following placement of truss, the corrugated top was covered by concrete floor slab and tile surface. Underneath, a network of utility and air conditioning ducts traverse the 32-inch deep-cavity.

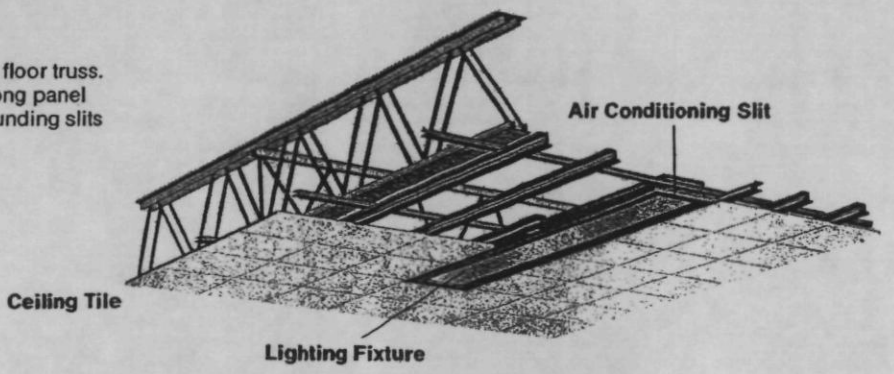
Looking upward at the same floor truss. Ceiling tile is in place. The long panel provides lighting, with surrounding slits for air conditioning.

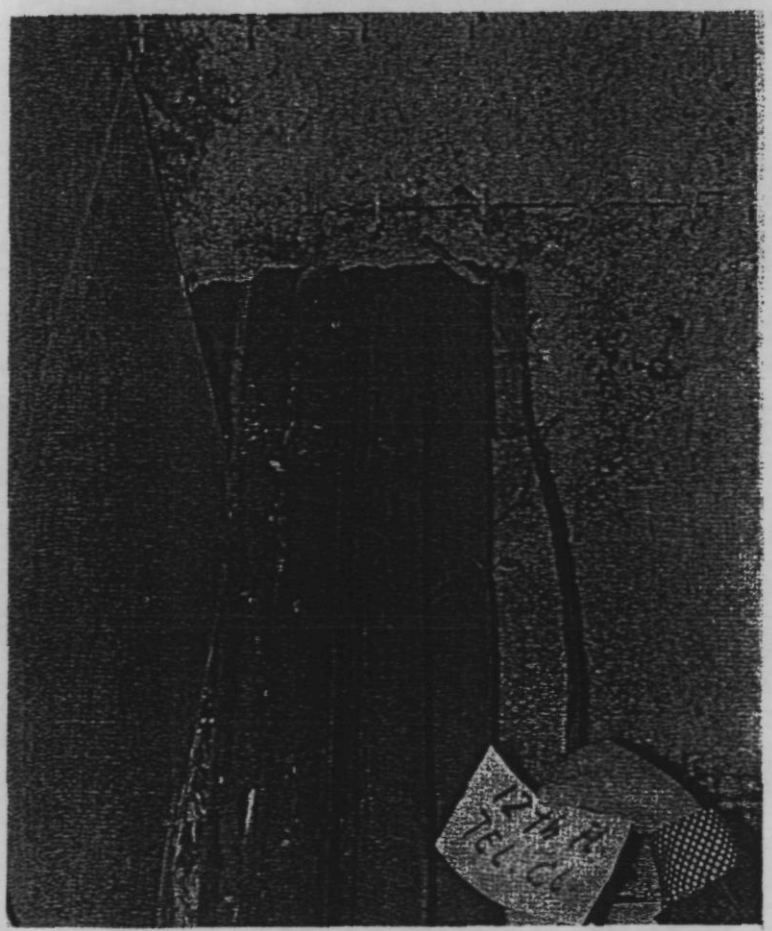
Telephone cables passing through opening in closet floor. Fire damaged cables have been replaced. Note the spalling of concrete.

However, two unsatisfactory conditions remain in connection with the telephone installation. Cables passing from one closet to another closet on the same floor pass through the plenum above the hung ceiling. The exposed cable insulation is combustible and constitutes a hazard because fire will be drawn into the plenum and the insulation will intensify the fire at this point. The second point is where the telephone cables pass through the mechanical equipment levels. Large groups of plastic insulated cables pass through one of the air handling rooms for the air conditioning system in a location where fire in the cables could spread smoke to as many as 32 floors. Smoke detectors at the filters would prevent this smoke from being recirculated but would not prevent smoke travel through the shafts when the system was shut down.

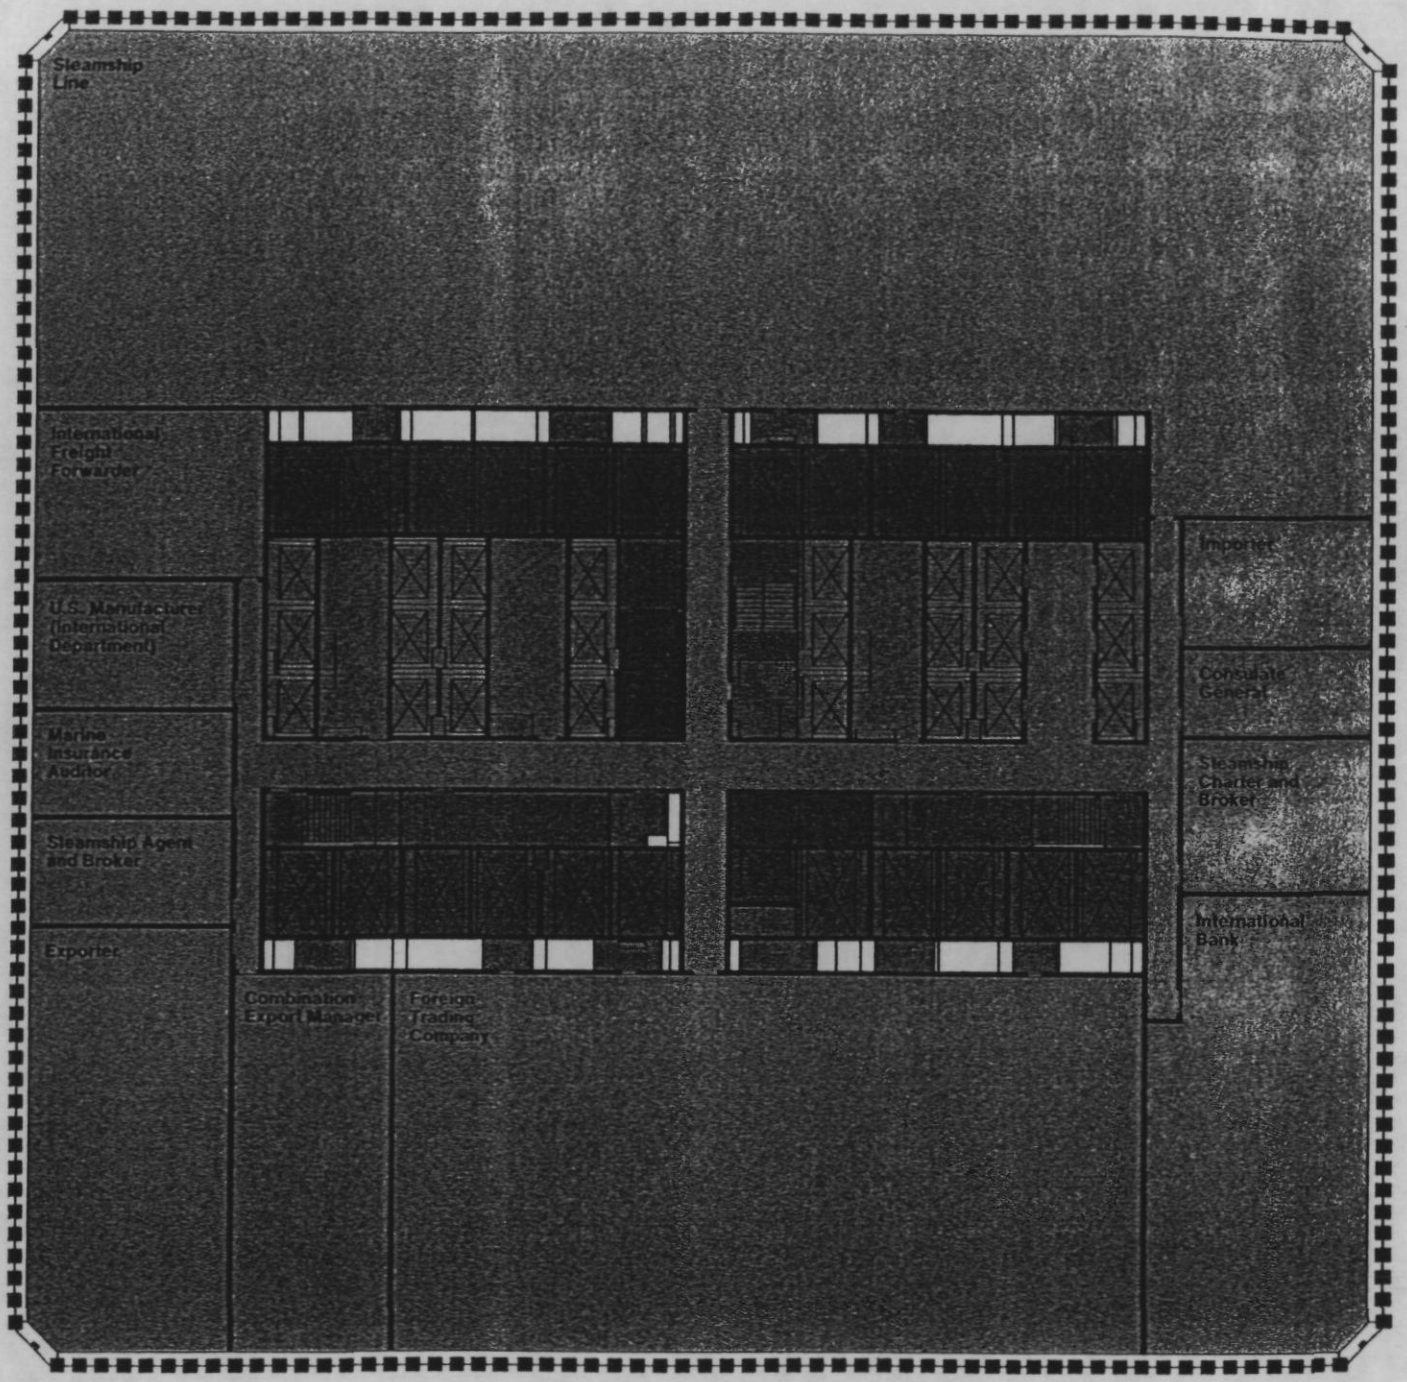
Plan of a typical tower building floor indicating areas occupied by

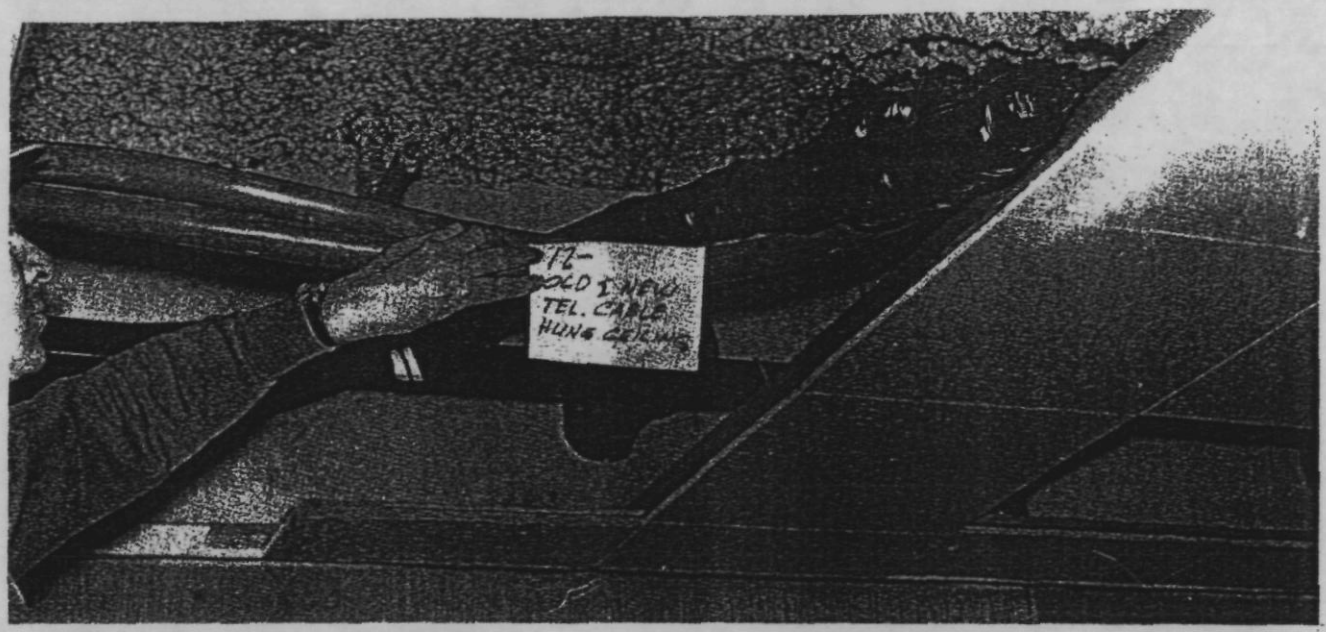
southeast corner of the core. It should be noted that the air conditioning is not operated at night so there was no movement of air via this system prior to this purge. Telephone cables in the plenum were ignited by the fire. Because of openings around the cables where they passed through the telephone closet walls and because of louvers in the telephone closet door, fire penetrated the closet to ignite telephone panel blocks and cables. Fire spread to upper and lower levels through openings about 12" x 18" in the floors of these closets. Cables passed vertically through these openings but no firestopping was provided for spaces around the cables. The polyethylene and polyvinyl chloride cable insulation and plastic panel blocks burned readily so that virtually all combustibles including the fire retarded wood panelling on the telephone closet walls of the 10th and 12th floors was destroyed. Fire emerged from the telephone closets on the 12th and 13th floors in the same manner it entered on the 11th floor. Fortunately, there were relatively small amounts of combustibles near the closet doors on these floors so that the fire department had no trouble controlling these blazes. Meanwhile, back on the 11th floor, the heated gas reached the return air outlets at the southeast air conditioning shaft, fusible links melted and closed the shutters to the shaft. Smoke and fire gases could not pass into the southwest quadrant of this floor because a one-hour fire partition had been erected at the west end of the Saunders' office to subdivide the floor area in accordance with New York City Local Law #5. Some heated gas was being drawn around the core to the northeast and northwest return air outlets but closing of these protective dampers at the southeast shaft now caused all of the fire gases to flow to the north end of the building. Eventually, the fusible link on the shutter at the northeast shaft operated and closed the shutter to the shaft here but it is believed that the fire was under control at this point. However, high temperatures in the plenum radiated enough heat into the offices to the north of the fire to melt plastic phones and char papers on desk tops, but ignition did not take place. The fire in the file room was of particular interest because of intense burning at opposite ends of the file room. It appeared at first that the fire originated in this section but further investigation showed that the intense fire at the east end of the room could be attributed to the flammable duplicating fluid and at the west end of the room to proprietary telephone equipment with plastic insulated cables and components, construction debris, file storage, and other combustible storage. A question raised after the fire was why the smoke detector in the plenum at the south east return air shaft did not operate earlier. Since the fire started at the opposite end of the office and the air conditioning was shut down, no air was being drawn past this

Telephone cables in plenum above hung ceiling. Note opening in closet wall.

It is recommended that communication wiring and equipment be subject to the same inspection procedure and requirements for compliance with the National Electric Code as is required of power wiring.
